Subject: **HISTORIC PRESERVATION ASSESSMENT**

Brewster Building

5 Aurora Street

Robison Building Analysis Project No. 2020.148

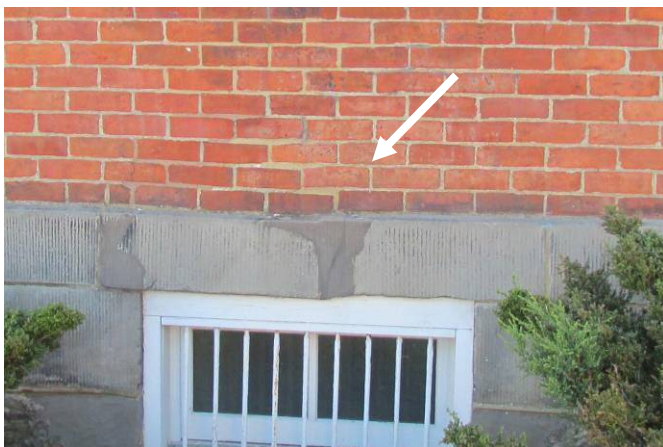
**Figure 5**

*A view of a basement window on the south elevation of the Brewster Store. Note the mortar repairs to the foundation stones and the dip in the brick coursing above.*

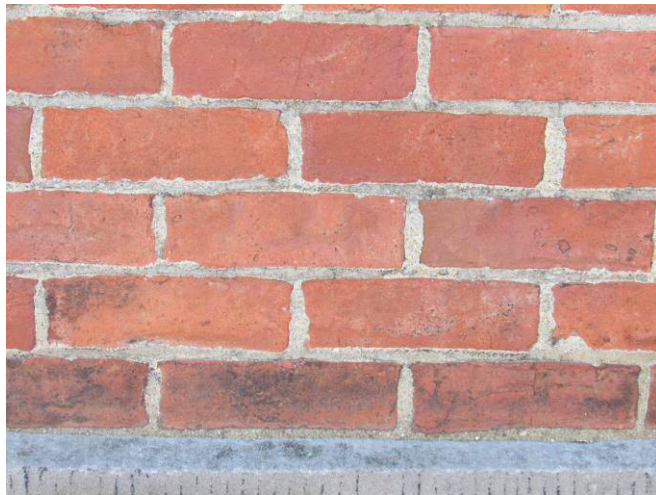
**Figure 6**

*A detail showing a representative area of sound brick.*

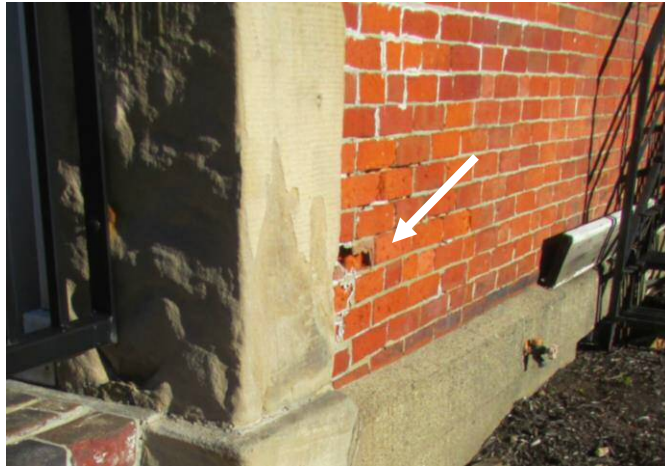
Figure 7

Most of the exterior brick walls are in good condition. However, there are two primary areas where deterioration has occurred. The first of these is near the south entrance of the building. It is probable that constant use of de-icing salts has contributed to the observed extreme weathering. Salt dissolves into water which is then absorbed into the porous brick. When the water evaporates, the salt crystallizes. As crystals grow, they expand and damage the brick. Switching to calcium magnesium acetate as a deicer avoids this type of damage.

Figure 6 shows heavily weathered brick, including units that have hollowed out and weathered. Mortar joints are in need of repointing in this region as well. The current brick steps are a later alteration to the building. It is probable that sandstone slabs were used for the original steps.

*A view of deteriorated brick near the south entrance.*

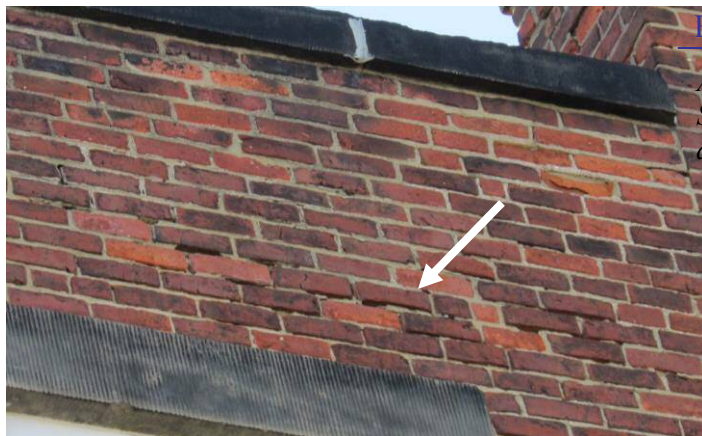
The parapets of the building are in poor condition. This is a common condition for brick structures because there is no warm surface to aid in drying out the parapet. While most of the brick wall has a warm interior on the inside face that dries out the wall in winter months, the parapet is surrounded by ambient temperatures. In winter months when freeze-thaw damage is most likely, the brick of the parapet are more likely to have water in their pores. A parapet is likely to experience more cycles of freeze-thaw due to their smaller mass. Finally, if the coping is not waterproof, the parapet will receive more moisture than the vertical walls below. Figure 8 shows missing mortar joints and some hollowed out brick in the parapet of the store.

*A view of the west parapet of the Brewster Store. The arrow points to an area of deteriorated mortar joints and brick.*

The coping stones on the parapet are sandstone. Sandstone is relatively porous, and will allow water to seep through slowly and wet the parapet. Installing sealant at the joints between coping stones can help, but due to the porous nature of sandstone, sheet metal flashing is best. Flashing can be installed on top of the coping stones economically, or it can be concealed under the coping units without substantially changing the look of the building.

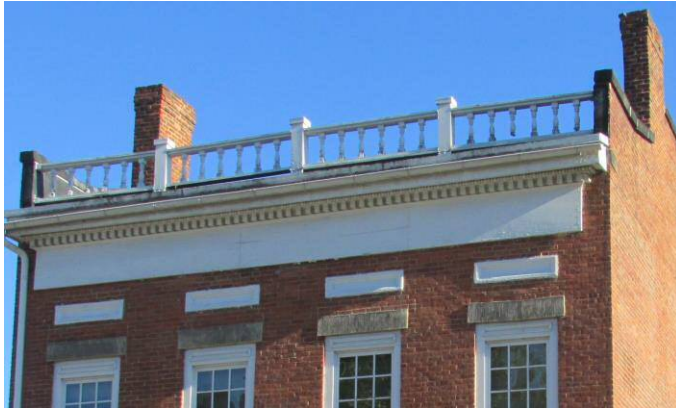
Figure 9

The parapets are thin and may need some stiffening in order to address the code-mandated wind loads on the building. It is likely that the balustrades which run between the free ends of the parapet can be fastened to the brick with sufficient capacity to address wind loads. The wide spacing of the current balusters was probable a cost-saving measure when the wood balustrade was replaced.

*A view of the upper south façade, showing the extensions of the parapets and the position of the balustrade..*

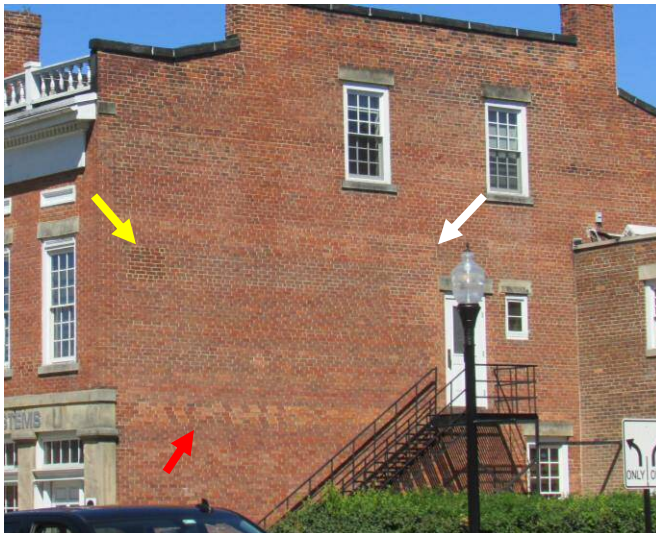
Figure 10

Different brick colors and patterns indicate some changes to the east elevation over time. The white arrow points to a rectangular opening which may have been a later window. The yellow arrow points a square area of replacement brick that may have been a window or opening. The red arrow points to a line of brick that has been replaced, extending along the east elevation. Most of these brick anomalies likely date to the Italianate structure which abutted the store in the late 19<sup>th</sup> century. A photograph taken in the early 20<sup>th</sup> century (note the electric wires in Figure 11) shows the outline of the interior plaster finishes applied to the east elevation during this period.

*A view of the east elevation showing anomalies in the brick work which likely indicate previous openings or other features.*

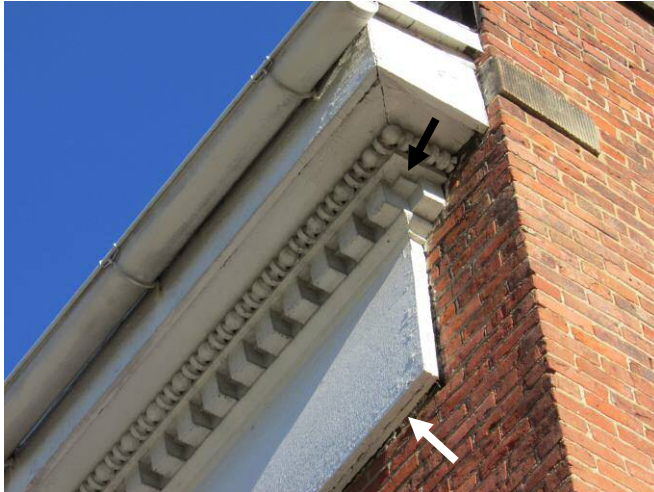
Figure 20

The wood cornice at the roofline on the south elevation is likely a replacement of the original. The cornice consists of a boxed-out projection, then a bead-and-lozenge molding, then a series of dentils (wood blocks), and then a frieze board below. Details of this cornice are more typical of a date well after 1839. The frieze board below the projecting cornice is built up from two planks, something that would be less likely to be done in 1839 when old-growth lumber was still available. Also, the dentil blocks are connected by a low relief block, and that level of detail and sophistication that was less likely to be found in the 1830s. The current cornice and frieze board may date to the establishment of the First National Bank of Hudson.

*A detail showing the cornice above the south façade. Note the two-ply frieze board (white arrow) and the low relief block between the dentils (black arrow).*

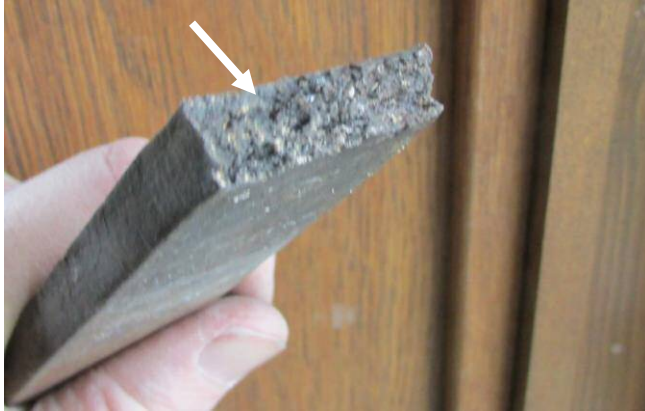
Figure 40

The broken end of the iron strap in the figure above was examined. It has the fibrous structure typical of hand forged iron. Slag inclusions tended to form thin planes in the metal when hammered, and break surfaces tear along these planes, forming the fibrous surface.

*A photograph showing the break surface on the iron strap in the preceding figure where it was broken when the queenpost diagonal was removed.*

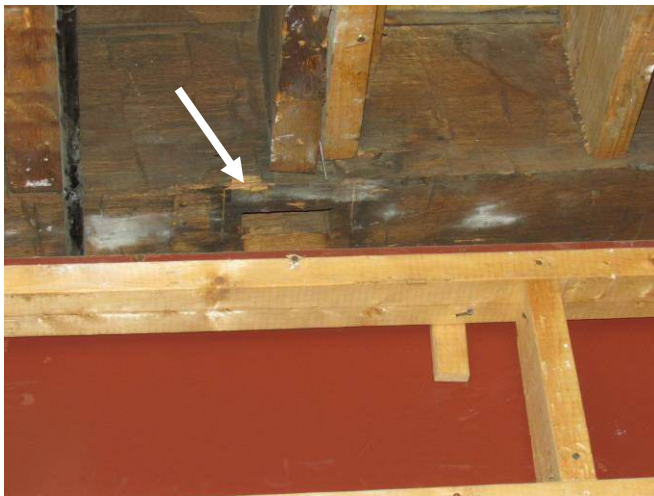
Figure 41

This queenpost truss would have been highly loaded, and it appears that later props were installed under the hewn beams to carry the load. Mortises have been cut into the bottom of several of the hewn beams. Theoretically, additional posts would not have been required had the queenpost arrangement functioned satisfactorily. These mortises suggest that the structure was adjusted and reconfigured to address deflections and distortions. Logically, iron hangers at the base of each queenpost would have been the weak link in the system.

*A photograph showing an existing mortise cut into the bottom of a hewn beam.*

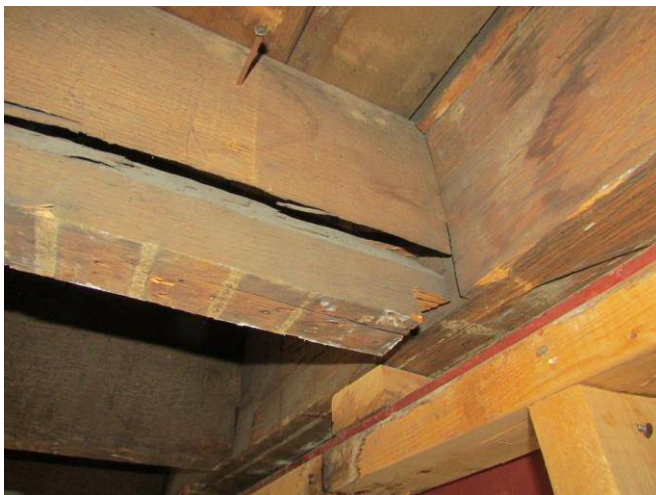
Figure 44

Leander Starr was a clever carpenter and devised a complex framing system for the floors. The queenpost truss on the second floor carried load from the center hewn beam on the third floor, and most of the load on the second floor. The magnitude of loading was likely too much for the iron straps which held the queenpost truss together. However, it shows intelligence and three-dimensional thinking of Leander Starr in designing the structure. There are few failures of existing framing members. Only a single joist supporting the 2<sup>nd</sup> floor was observed to have a shear failure.

*A detail showing a 2<sup>nd</sup> floor joist with a shear failure at the tenon.*
