Subject: **HISTORIC PRESERVATION ASSESSMENT**

Brewster Building

5 Aurora Street

Robison Building Analysis Project No. 2020.148

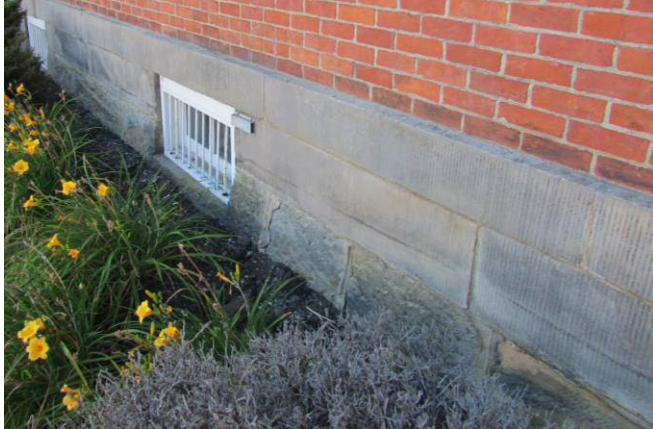
**Figure 4**

*A view of the Brewster Store from the south.*

Windows have been cut into the foundation on the west elevation. They appear to have been cut in following the original construction. For example, in Figure 4 the window in the foundation was inserted underneath a window in the brick wall above. This is good practice, as it preserves a ‘column’ of solid masonry extending from the roof line down to the foundation. However, in this instance there was a joint in the top foundation course over the basement window. Without a single stone spanning the basement window opening, the stones have dropped and the brick coursing above had dipped. Mortar repairs have been installed to the foundation stones and the brick has been repointed above. It is likely that the opening was cut into the foundation to serve as a coal chute.

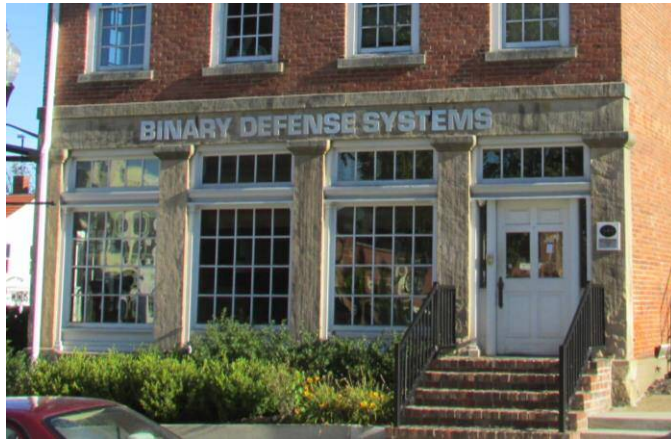
Figure 13

*A view of the lower south façade with the sandstone pilasters.*

The sandstone features a ‘combed’ surface, with small vertical ridges formed with a toothed chisel. The pilasters are given definition with a border of horizontal combing. The sandstone is in good condition, with minimal weathering visible except where deicing salts were applied near the entrance.

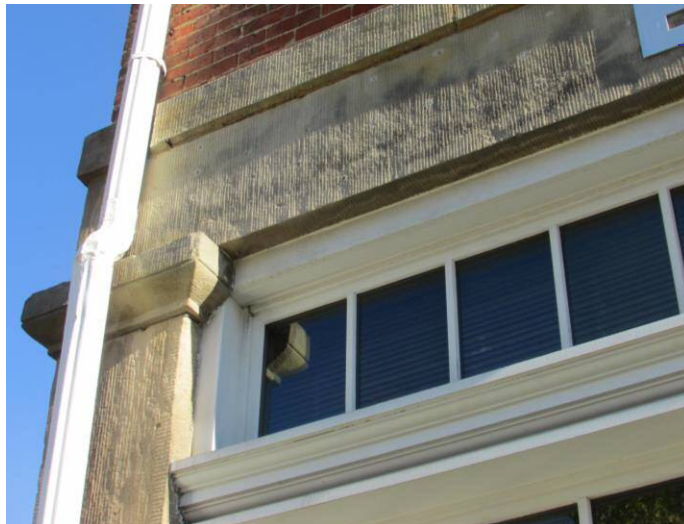
Figure 14

*A detail showing the stone tooling on the sandstone pilasters and entablature.*

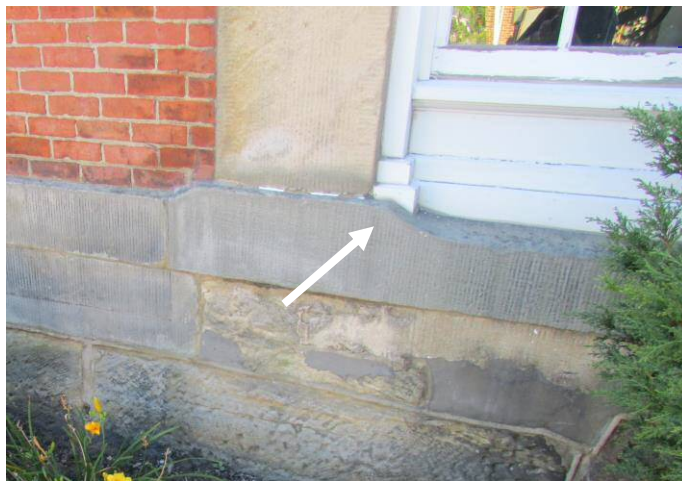
Figure 15

The stonework is well detailed. The window sills of the storefront windows have a lugged profile, meaning that when the wood jambs of the windows rests on the stone, the stone surface is higher. This encourages water the flow away from the wood windows and avoids the pooling of

water where the end grain of the wood can take it up and accelerate wood rot. This is a sign of an experienced and careful builder.

*A detail of a lugged window sill under a storefront window.*

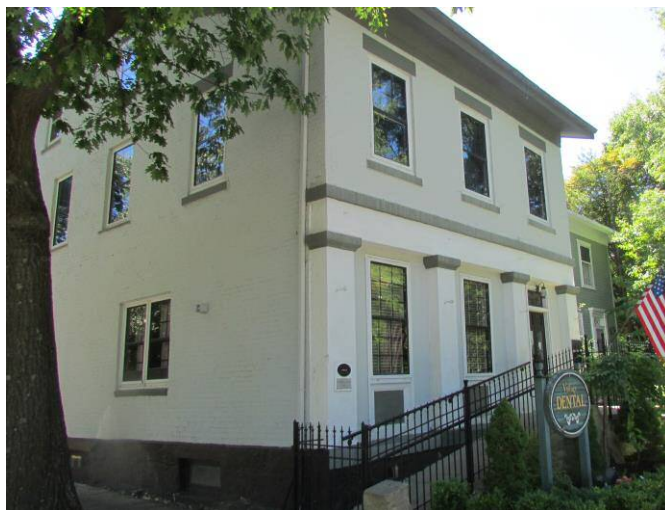
It is noted that the nearby Ellsworth store, currently a dental office, was constructed by Leander Starr as well and shares many details. Similar pilasters and entablature are found on the Ellsworth Store, although they have been painted over. Painting stone is not recommended because although paint is permeable to water vapor, it does retard its transmission. If moisture builds up behind the paint layer, freeze-thaw damage can occur in the stone during cold weather.

*A view of the Ellsworth Store, constructed by the same builder as the Brewster Store.*

The two windows noted by arrows in Figure 16 were not present in historic photographs. Perhaps it was anticipated that a single story building would be built adjacent to the store on the small lot, or shelving occupied the wall to the west. It is presumed that the window openings were created when the building was adaptively reused as a bank.

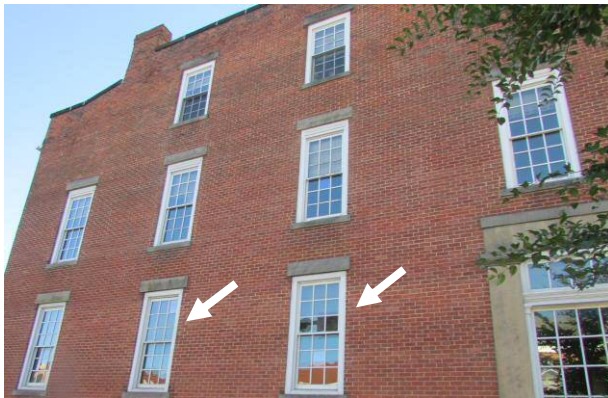
**Figure 17**

Sandstone lintels are used to bridge over window openings, with sandstone sills below each window. These sandstone elements are uncracked, indicating that there has been little settlement

*A view of the west elevation of the store showing the sandstone lintels and sills at each window.*

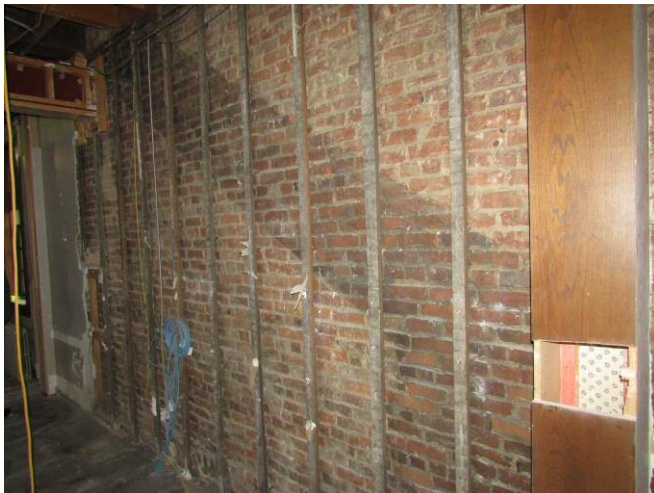
Figure 21

Selective demolition of interior 20<sup>th</sup> century finishes determined that a stair originally led from the south entrance up to the second floor. Ghost lines of the stair are visible against the east wall of the store.

*A view of the ghost lines showing the location of the original stair leading to the second floor. The wood furring strips date to a later period.*

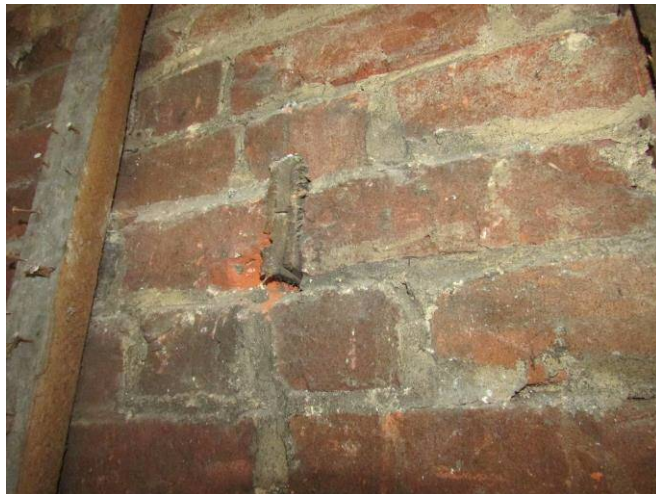
Figure 23

Wood inserts are present in the 'ghost' area of the stair. Such inserts were placed in the head joints of brick to provide a nailing substrate for moldings. In this case, it is probable that a base molding was installed above the stair treads and that these were fastened to the wood block shown in Figure 23.

*A detail showing a wood insert where moldings were attached to the brick wall.*

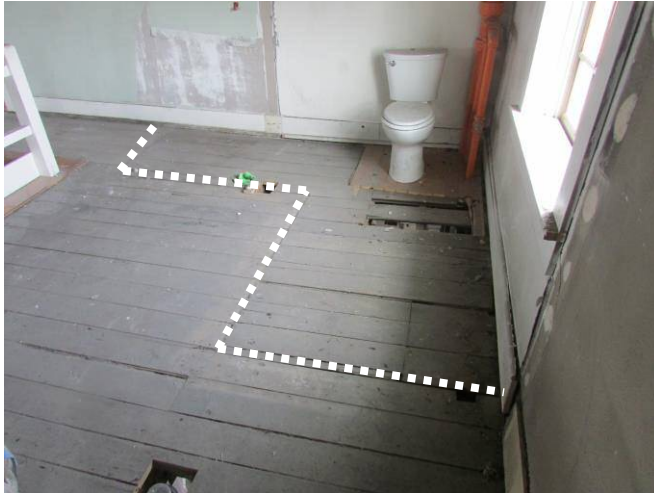
Figure 24

The second floor stair was originally located in line with the first floor stair, installed adjacent to the east perimeter wall. The seams between the original flooring and later flooring are visible in the northeast corner on the third floor, where the original stair made a 90 degree turn towards the west as it encountered an internal wall.

*A detail showing where the original stair existed onto the third floor.*

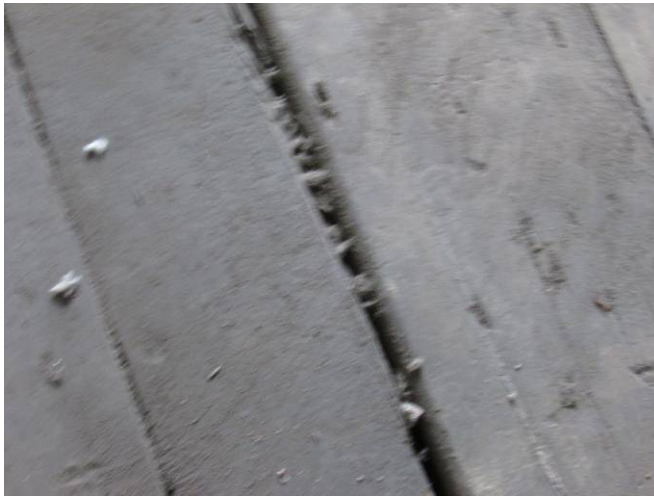
Figure 26

The junction between the original and in-fill flooring is distinguished by the bull-nose profile of the original flooring. Note that the in-fill flooring is narrower than the original flooring.

*A detail the bull-nose profile of the original third floor flooring adjacent to the in-fill flooring installed when the stair was moved.*

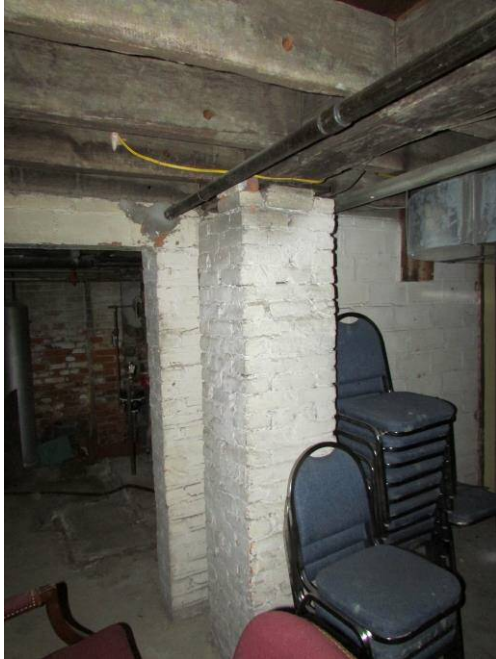
Figure 28

The brick piers directly support the hewn beams which support the first floor. The joists have reciprocating saw marks and are original to the building.

*A detail of a brick pier which supports the hewn beams framing the first floor.*

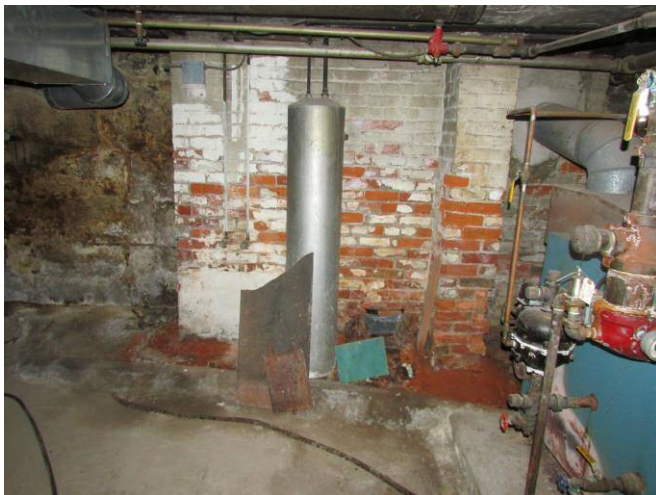
Figure 29

In addition to the foundation supporting the bank vault, there is a newer foundation which supports the fireplace in the southwest quadrant of the building. This foundation is not on the HABS basement plan, so it was either not included in the plan or it dates from after 1977 creation of the HABS drawing.

*A view of the brick foundation supporting a later fireplace.*

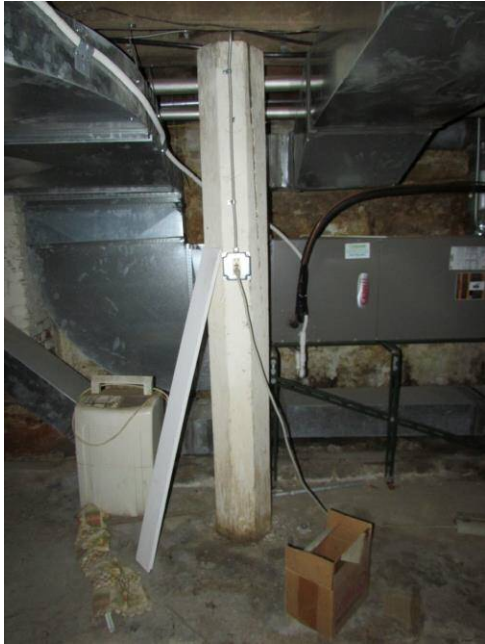
Figure 30

There is a wood column in the basement that has the same profile as the wood porch columns of the adjacent Brewster Residence constructed in 1853. It is likely that the wood column dates from after that time, perhaps used to shore up the floor where there was an especially heavy storage of goods.

*A view of a wood column in the basement.*

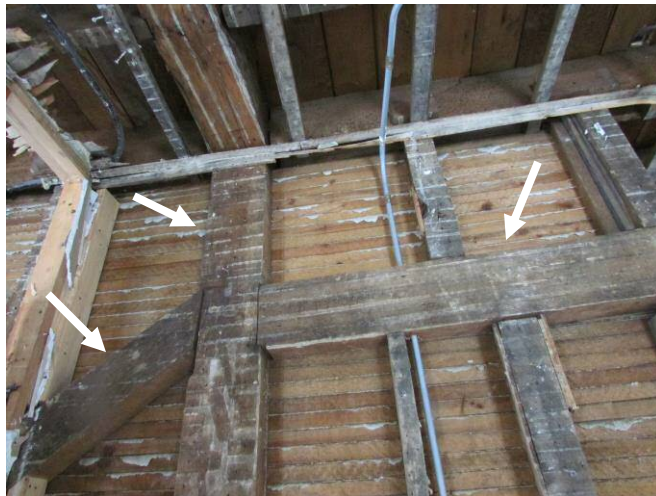
Figure 32

*A photograph showing remnants of the queenpost truss that originally supported the second floor.*

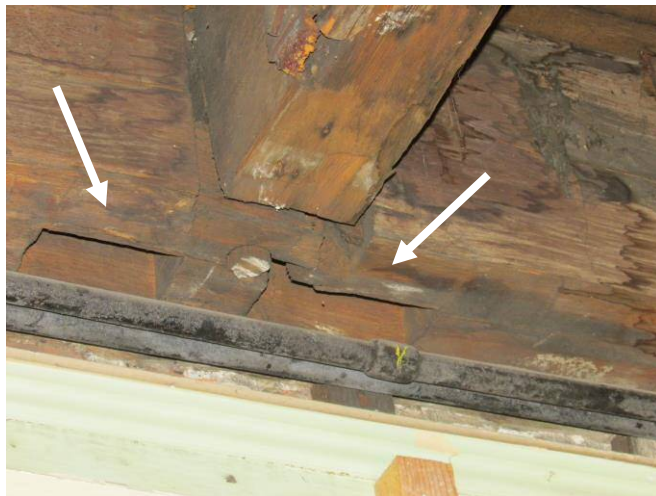
Figure 35

The north extent of the queenpost truss originally had a substantial post underneath the end of the truss. Currently, the bank vault is located below the north extent of the truss, but a double mortise is visible above the entrance to the vault, under the queenpost truss end.

*A photograph showing double mortises under the north extent of the queenpost truss.*

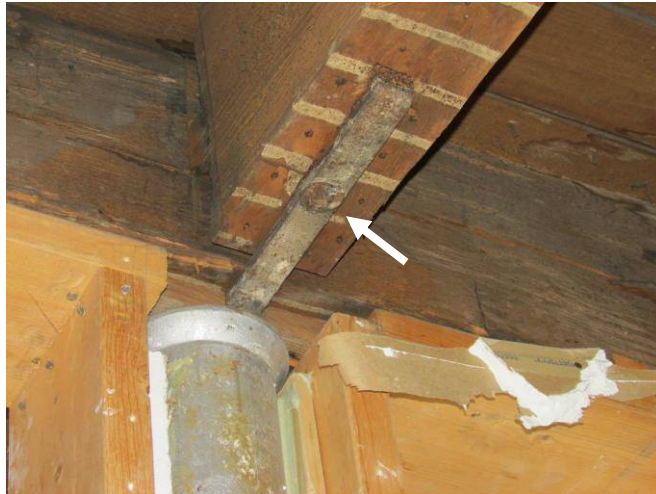
Figure 36

The horizontal members at the bottom of the queenpost truss (the bottom chord) are distinguished from the regular floor joists by their greater thickness. These members are in tension, and an iron strap was installed where the bottom chord members were interrupted by the hewn beam. The iron tension straps were installed by bending the strap into a U-shape and inserting the ends of the U into slots cut into the bottom face of the bottom chord. Large spikes were then used to fasten the strap to the bottom chord.

*A photograph showing iron straps which provided continuity past the hewn beam for the queenpost truss lower chord. The iron column is a later addition. The arrow points to the large spike fastening the strap to the bottom chord.*

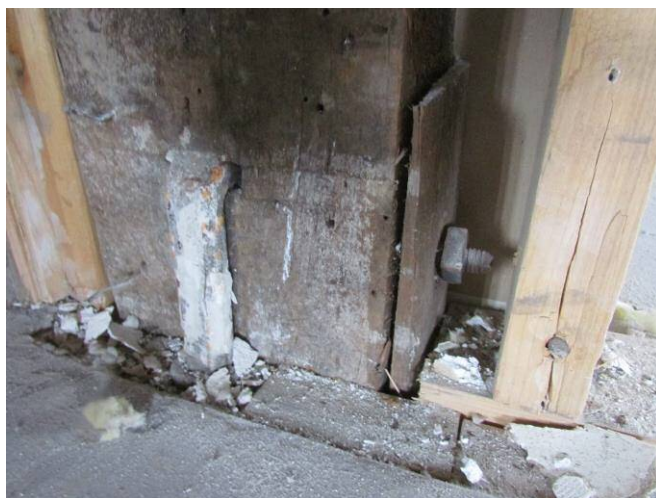
Figure 37

At the base of each queenpost, iron straps were used to suspend the hewn beams, enabling a column-free interior. The straps were bent into an L-shape, with the horizontal L set into a slot in the side of the queenpost and the vertical leg of the L was hammered into a round shape with threads cut into vertical leg. A large nut was then threaded on to the strap and tightened up to the bottom face of the hewn beam. An additional plate was installed with a through-bolt at the base of the queenposts, but the existing structure obscures how these plates were fastened to the hewn beam below.

*A photograph showing an iron strap and plate used to suspend the hewn beam from the base of a queenpost.*

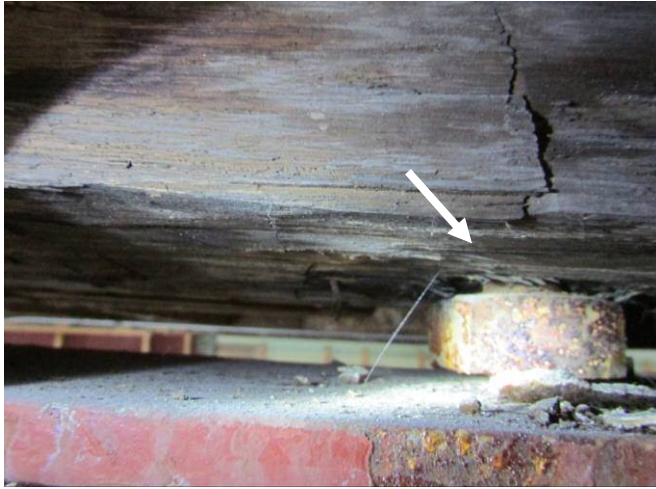
Figure 38

*A photograph showing the bolt threaded on to the end of the iron strap shown in the preceding figure. The red-painted steel beam installed in later years is visible in the base of the photograph.*

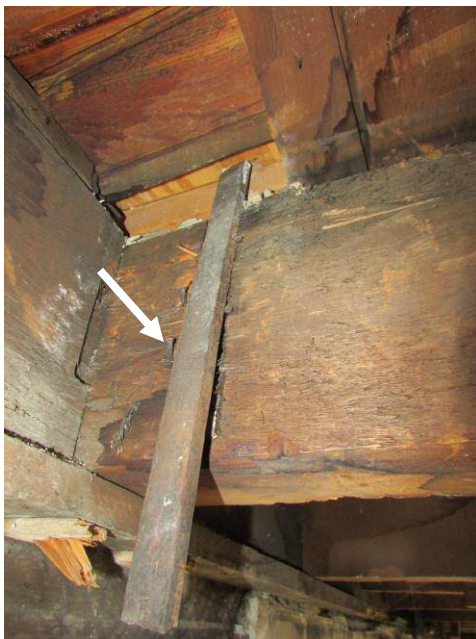
Figure 39

At the south extent of the queenpost truss an iron strap was used to fasten the diagonal to the bottom chord. Slots were cut into the sides of the bottom chord, and it is assumed that a U-shaped strap was installed over the now-missing diagonal. Cut nails were installed to each side of the slot and then bent over to retain the strap in the slot.

*A photograph the iron strap installed at the south extent of the queenpost truss. The arrow points to a cut nail bent over the strap to retain it in the slot.*

The broken end of the iron strap in the figure above was examined. It has the fibrous structure typical of hand forged iron. Slag inclusions tended to form thin planes in the metal when hammered, and break surfaces tear along these planes, forming the fibrous surface.

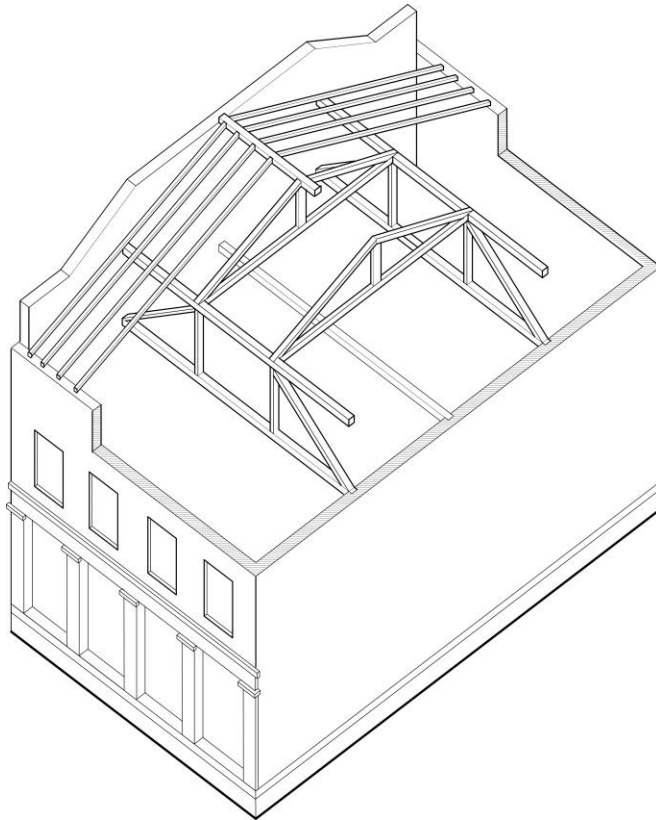
**Figure 42**

The roof and two of the bays are supported by a system of queenpost and simple triangular trusses. Since the ground floor had a column-free main store area, the roof loads had to be shifted to the masonry walls rather than be carried down through the lower floors. The Leander Starr installed two queenpost trusses running east-west and bearing on the exterior brick walls. These queenpost trusses support the third floor, but they also support the two triangular roof trusses. This roof system has supported the roof and third floor for about 180 years with little repair or additional bracing.

*An axonometric diagram showing two triangular roof trusses supported by two queenpost trusses at the third floor level. Note that lower framing has been eliminated for clarity, and only a few roof rafters have been shown so as not to obscure truss configuration.*

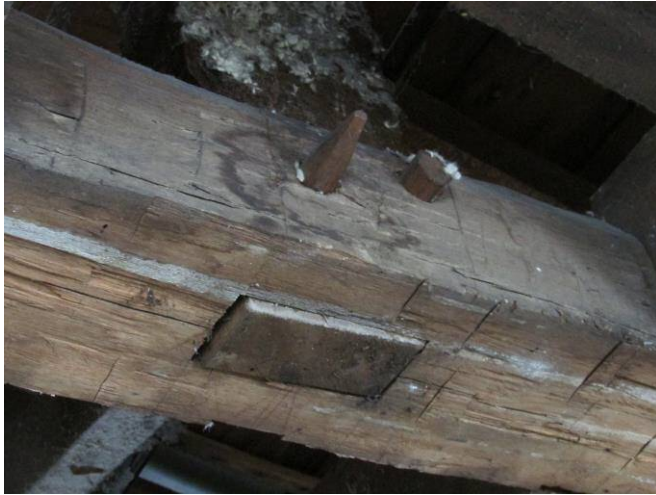
Figure 43

The triangular roof trusses show characteristic details from the 1830s, with mortise and tenon connections fixed by 'treenails,' or wooden pegs, driven into the connections. Large dimension timbers are hewn, while thinner planks have reciprocating saw marks characteristic of early water-powered saw mills.

*A detail showing the bottom chord of a roof truss showing the hewn surface, the tenon from a vertical member in the center of the truss, and the ends of the treenails which secure the tenon in the mortise.*

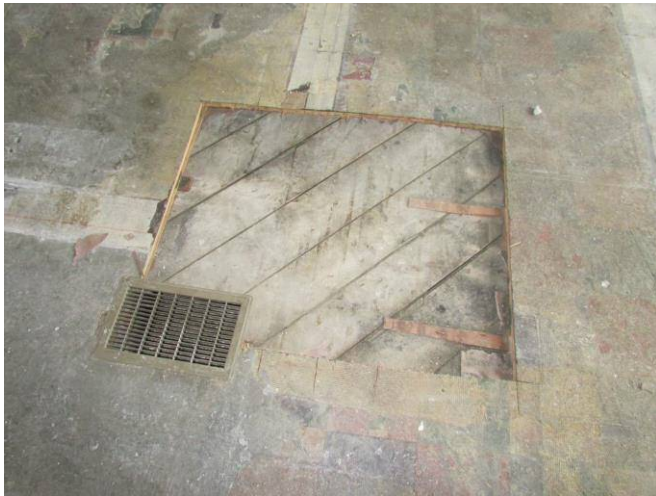
Figure 45

The first floor flooring is a later replacement. The subflooring runs diagonally to the supporting joists, a technique that was only used after the Civil War when balloon framing became common.

*A photograph showing the subfloor on the first floor level.*

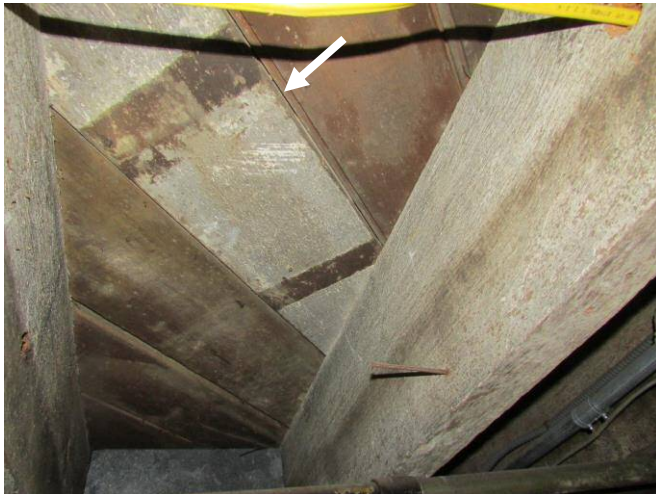
Figure 46

The subflooring appears to have been reused from another structure, as some of the subflooring planks have ghost marks from an earlier installation.

*A photograph showing a subfloor plank with ghost marks from a previous installation.*

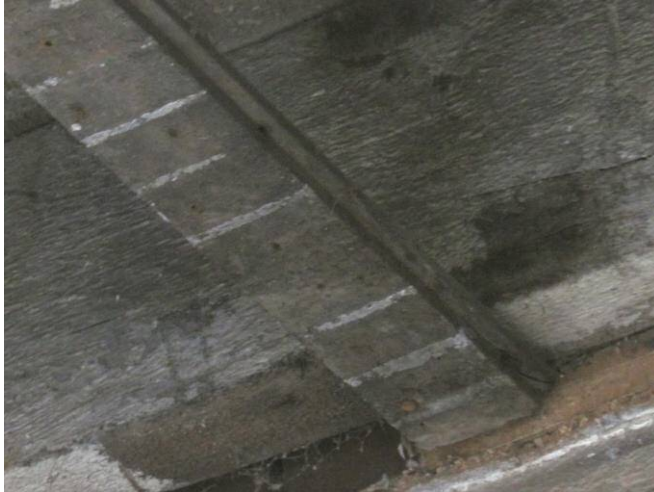
**Figure 47**

It is probable that the wood furring strips installed in the second floor to which the lath and plaster ceiling were attached were cut from the original flooring. Tongue and groove edges are visible on many of the furring strips, indicating that their first use was as flooring.

*A detail of a furring strip on the second floor ceiling which was reused and cut down from flooring. Note the tongue cut into the side.*

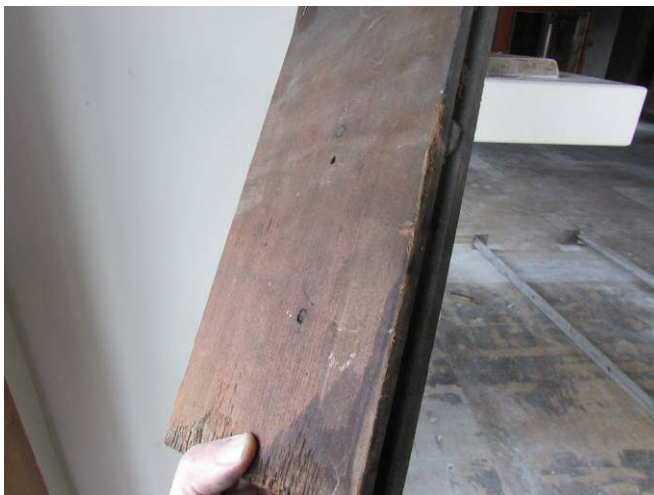
**Figure 48**

A fragment of flooring was recovered from the first floor ceiling which had been used to reinforce one of the queenpost straps. This, too, may be a piece of the original flooring on the first floor. The fragment is 5/4 inch thick, has a rough sawn bottom, and a hand-planed top. The parallel, shallow grooves in the top surface just visible in the photograph can be easily felt by running a finger across the board. Given the deterioration on one end of the fragment, it is speculated that it came from the floor near a doorway where it was occasionally wetted. Since there is no perceptible wear on the surface, it likely was in a corner behind the hinge side of a door where there was no foot traffic.

*A detail of a flooring fragment recovered from the 1<sup>st</sup> floor ceiling. Note the parallel shallow grooves on the surface.*

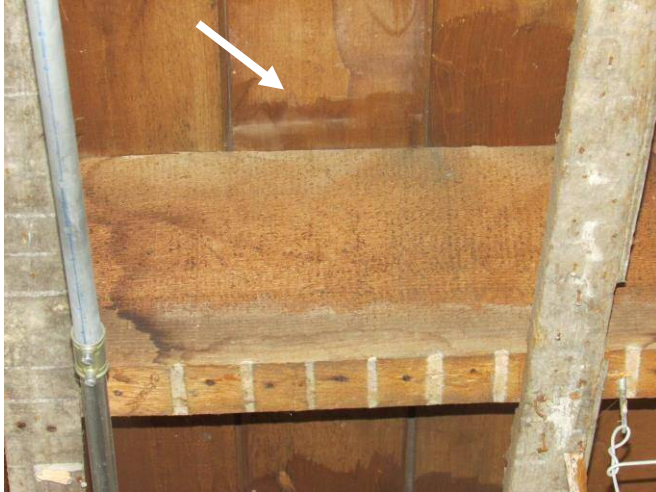
Figure 49

The flooring on the 2<sup>nd</sup> and 3<sup>rd</sup> floors is largely original. The supporting joists have reciprocating saw marks, characteristic of early water-powered saw mills. The flooring is tongue and groove of random width and the bottom surface shares the reciprocating saw marks. The floor boards also have been hand-planed fit the profile of the joists. Early sawmills were unable to produce planks

with a consistent thickness. Accordingly, carpenters often had to hand-plane the bottom of the floor boards to ensure a good fit. This was observed in the upper two floors of the Brewster Store.

*A photograph showing reciprocating saw marks on a floor joist and on the bottom surface of the flooring. The arrow points to where the bottom of the flooring planks were hand-planed to fit the profile of the joists.*

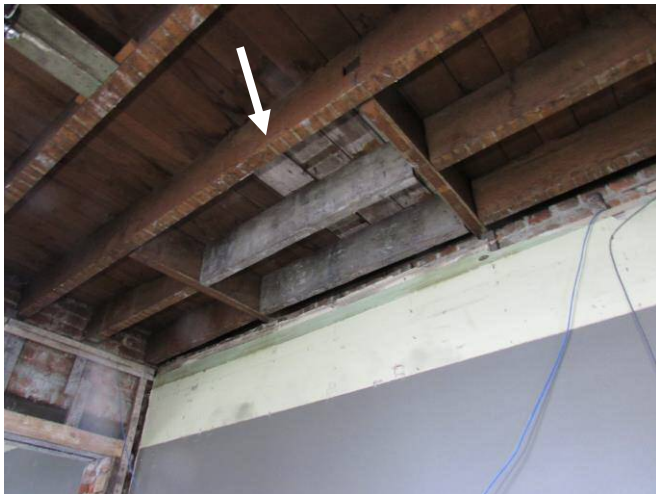
Figure 50

In the northwest quadrant of the building an opening is framed out in the floor structure. New joists, painted white, have been installed to fill the opening. This appears to have been an open hatch to facilitate hoisting up items to the upper floors. Framed openings are present at both the 2<sup>nd</sup> and 3<sup>rd</sup> floors.

*A photograph showing an opening framed out on the second floor framing.*

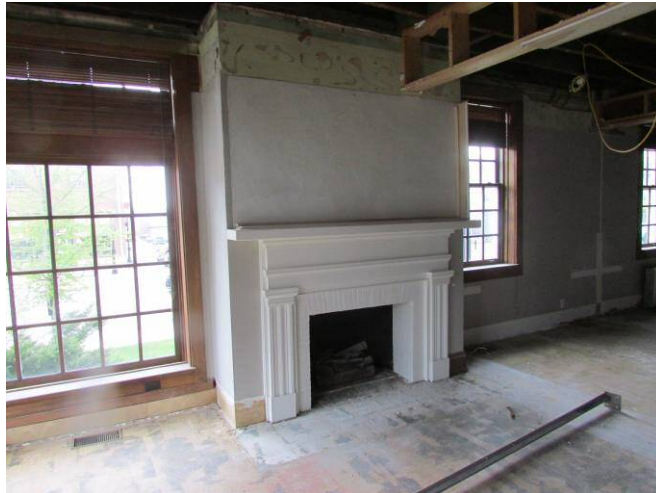
Figure 51

Original finishes have been removed from the entire 1<sup>st</sup> and 2<sup>nd</sup> floors. The only decorative feature on the first floor is the fireplace in the southwest quadrant, whose foundation was discussed above. As was noted, if the HABS drawings are accurate, the feature dates from after 1977.

*A photograph showing the existing fireplace on the first floor.*

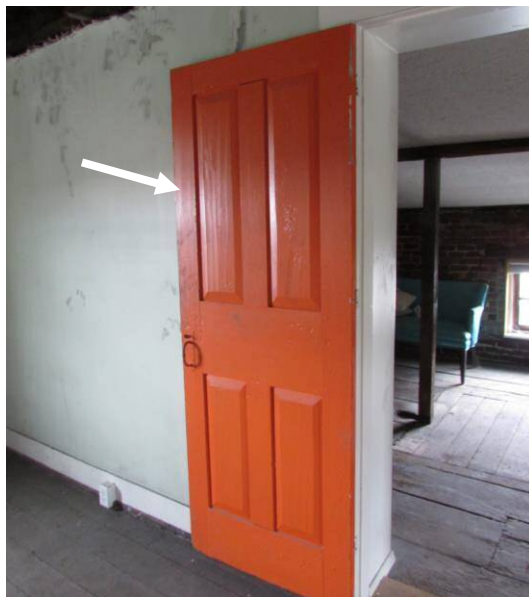
Figure 52

The center bays of the 3rd floor show characteristic finishes from the first half of the 19<sup>th</sup> century, and are likely original. There are two four-panel doors which show characteristic hand-planed marks, mortise and tenon connections between the styles and rails, and pegs holding the doors together.

*A photograph showing one of the two doors on the third floor with visible hand-planed marks on the back side.*

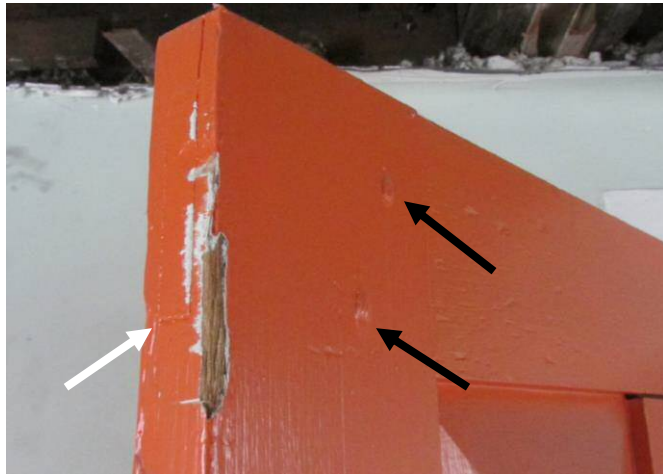
Figure 53

*A detail showing the tenon (white arrow) and pegs (black arrows) used to assemble the door.*

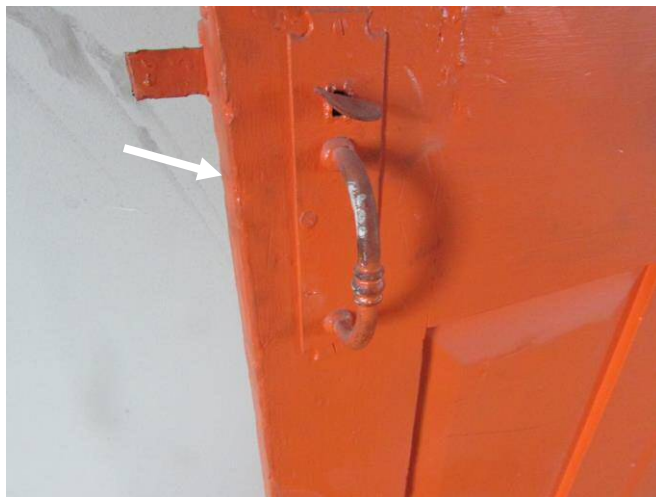
Figure 54

The two doors have thumb latch hardware which is typical of the 1830s in Ohio.

*A photograph showing one of the two doors on the third floor with visible hand-planed marks on the back side.*

Paint analysis of the doors shows that the earliest finish color remaining was a warm gray (see Appendix A). However, underneath the primer coat for the light gray finish coat was a residue of a varnish. It is possible that the paint was stripped from the doors and repainted with the warm gray color. There were between 3 and 5 paint layers on the doors (excluding the primer coat). This is a small number of paint layers for a building dating to 1839—more commonly one would expect 10-15 paint layers for a building of this age. This makes it more likely that the residue on the wood observed in the paint analysis was due to paint stripping.

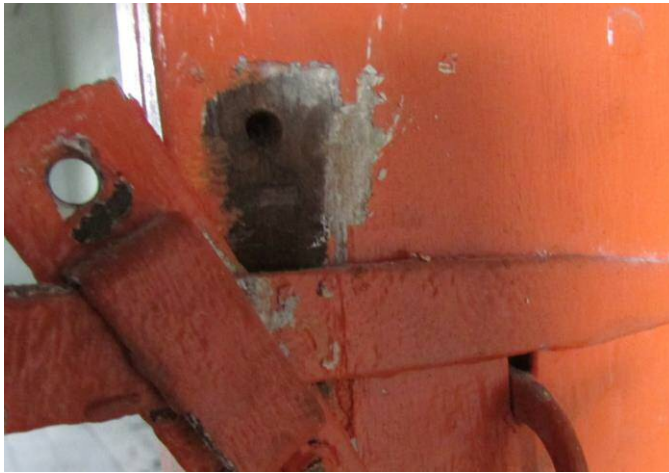
Figure 55

A portion of a thumb latch was removed to see if any paint residue might remain under the hardware. Unfortunately, no colors other than those present in the paint analysis were observed.

*A photograph showing the bare wood underneath the door latch.*

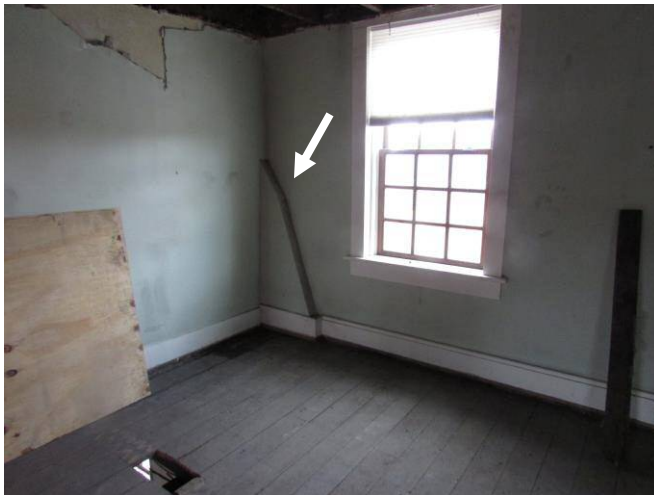
Figure 56

The third floor retains the flues leading to the chimneys. It seems most likely that stoves were used to heat the building, as there is no evidence remaining in the framing of any hearths.

*A photograph showing the projection in the exterior wall which houses a flue leading the chimney above.*
